## Failures and leak inspection techniques of tube-to-tubesheet joints: A review

Dinu Thomas Thekkuden<sup>a</sup>, Abdel-Hamid Ismail Mourad<sup>a,b,c,\*</sup>,  
Abdel-Hakim Bouzid<sup>d</sup>

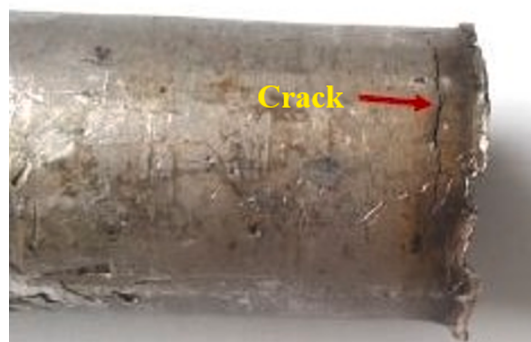
Fig. 2. Crack in the outer tube surface close to tube-to-tubesheet joints [12].

commissioning. In their study, the cracks generated at the tube and tubesheet region propagated as a result of stress corrosion cracking, thermal fatigue and localized corrosion [12].

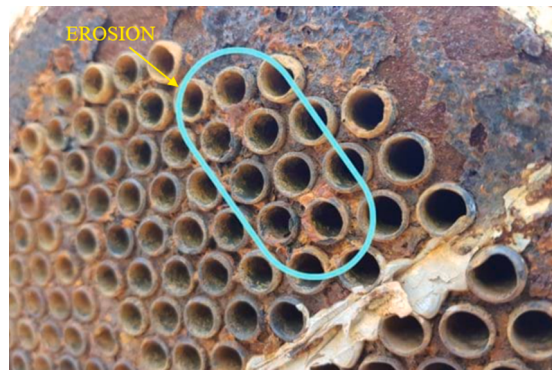
Fig. 7. Erosion at Tube-to-tubesheet [50].

Anna Kosnica et al. claimed that the impurities at the nano and micro scale present in the medium can initiate the erosion along the tube walls and tube inlets at tube-to-tubesheet joints. The erosion increases with the larger particle size whereas the low mass of the nano particles reduces the erosion rate considerably [42]. Tube-to-tubesheet joints [43], tube bends [44] and the tube near baffles are the most affected structural parts due to the direct hitting of media with suspended particles at a higher impingement angle. Weimin et al. reported the catastrophic behaviour of erosion increases sharply with the decrease in the particle size [45]. But Habib et al. proved that the above particle size dependency on the erosion rate is valid only at a lower header inlet velocity whereas the particle size effect is negligible at higher inlet velocities [46]. Willem et al. found out that the influence of velocity on the erosion-corrosion is higher than on individual erosion or corrosion due to the combined effect of erosion and corrosion [47]. The debris is mostly accumulated on the tubesheet at the tube-to-tubesheet joints causing irregular velocity and turbulence. A fast streaming velocity causes oscillation in the tube resulting in the wear of tube and baffles while turbulence develops a local pressure surge and shear stresses carving out the material [48]. In addition, turbulence is also developed at the tube and shell inlets due to the splitting of media into small particles having localized velocities. The combination of turbulence and high localized velocities at a higher operating temperature has a synergistic effect on accelerating the damage of tube-to-tubesheet joints. Hot vapours and bursting of the bubbles at the tube entrance also accelerate the deterioration process. High pressure at a lower impingement angle exerted by water and air jet for flushing the scales out during a periodic inspection causes erosion [33]. Other than the velocity, the flow impingement angle and flow patterns are also found to affect the erosion corrosion-induced corrosion. Based on the experiments conducted by Khayatan et al., the particle force at various angles on the tubes depassivate layer from the metal and they concluded that the highest erosion rate is observed at the impingement angles ranging from 30° to 50° whereas the highest corrosion rate is observed at the impingement angles from 40° to 60° [49]. Frequent number of the impacts, high normal and low tangential stresses are the reasons for corrosion at a higher impingement angle. The schematic representation showing the erosion-corrosion is shown in Fig. 6. The erosion at the tube-to-tubesheet joints is depicted in Fig. 7.

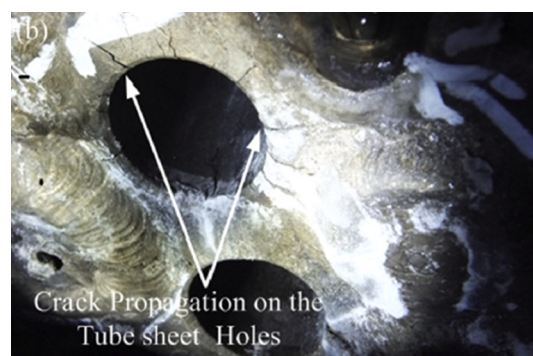
Fig. 19. SCC cracks at tube-to-tubesheet joints [281].

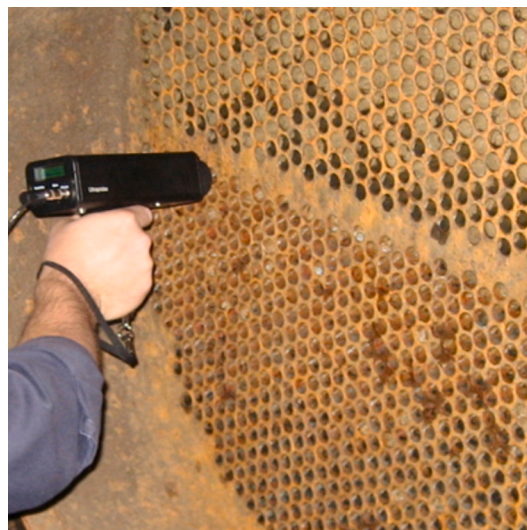
**Fig. 21.** Ultrasound leak detection at the tube-to-tubesheet joint [309].

The pressure-based passive ultrasound method is widely adopted for detecting the leaks in the heat exchanger tubes [295]. The gases from the pressurized enclosed region travel to low-pressure regions through the cracks. These gases or liquids escaping from the enclosed tubes or shells turns turbulent and therefore, the fluid escaping from the leak produces a hissing sound. The ultrasonic leak detector scanned over the suspected parts detects the frequency of this hissing noise produced by the leakage. The ultrasonic leak detectors are designed to capture the sounds within specific frequencies ranging from 38 to 42 kHz [296]. Osama et al. confirmed that the frequency of measured leakage was always less than 50 Hz for the leakage in the pipelines [297]. The ultrasonic listening devices are run over the test region till the loudest point is reached. Listening rods, geophones [298] and aquaphones are the scanning devices used for ultrasonic detection [299]. Most of these devices use piezoelectric sensors and amplifiers for detecting sound and vibration [300,301]. Wireless sensor networks and radio frequency identification are equipped with data acquisition systems for monitoring the leakage [302]. The leakage level is estimated from the captured amplitude of the sound using leak noise correlator. However, the more leakage, the greater will be the ultrasound produced. The ultrasonic detection is suitable and reliable for tube-to-tubesheet joints due to the easiness of inspecting the exposed tubesheets at either end of shell and tube heat exchanger and scanning process. Given high significance to the tube-to-tubesheet welds, Guo et al. inspected the tube-to-tubesheet joints for defects using a phased array ultrasonic technique with appropriate phased array parameters and found porosities and lack of fusion flaws at the welded tube-to-tubesheet joints [303]. Yokell recommended ultrasonic inspection and helium leak sniffer test for inspecting and assuring the tightness of welded tube-to-cladded tubesheet [304]. Lillie applied ultrasonic and radiographic inspection in addition to helium leak test, liquid penetrant test and visual test for testing the butt welded 2 1/4 Cr-1 Mo steel tube-to-tubesheet in a sodium-cooled fast breeder reactor [305]. Pai et al. recommended to strictly use ultrasonic testing of tubes, tube-to-tubesheet weld joints and shell weld joints if radiography test is unavailable for evaluating the quality of welds in a 500MWE prototype fast breeder reactor [306]. Marino and Carminati proposed a methodology with an equipped data acquisition system to enhance the ultrasonic scanning and defect characterization explicitly for tube-to-tubesheet welds [307]. Yoon et al. suggest ultrasonic testing over eddy current testing nuclear power plant steam generator tube and joints because the latter lacks the ability to accurately indicate the size of the defects [308]. Ultrasound leak detection at the tube-to-tubesheet joint is shown in Fig. 21.

The gas flowing through the leaks will produce ultrasonic energy which can be detected by an ultrasonic leak detector. The sensitivity is limited to  $10^{-3}$  Pa m<sup>3</sup>/s, and due to the low value, it is not applicable to check the vessels containing hazardous liquids inside. In contrast to the above statement, Bergoglio and Mari have mentioned that the sensitivity of the acoustic leak detection systems goes up to  $10^{-4}$  Pa m<sup>3</sup>/s [310]. The detector which is capable of detecting the acoustic frequency ranging from 20 to 100 kHz is in practice for leakage detection [311]. The leakage should be less than  $1 \times 10^{-2}$  Pa m<sup>3</sup>/s for acceptance [312]. According to UK Health and Safety Executive (HSE), the impact of the gas leaks can be classified into minor (gas leak <0.1 Kg/s); significant (0.1 Kg/s < gas leak <1 Kg/s) and major (gas leak >1 Kg/s) [313]. The ultrasonic leak detector pigs are one of the newest techniques for determining the leaks in pipelines automatically. It uses hydrophones and specially developed software to detect the leak generated sounds. The pigs can print out the time at which the leak occurred, and the leak points will be traced by a magnetic marker system [314]. The technique can detect the leak irrespective of the gas or liquid. The technique is highly compatible with a vacuum and pressurized systems and the leaks at a greater distance can be easily detected. Due to high sensitivity, a chance for background noise interrupting the inspection is high [315].

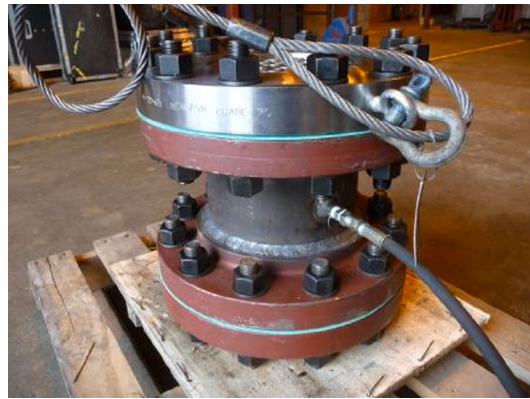
Fig. 23. Hydrostatic testing of mock-up tube-to-tubesheet for leakage [320].

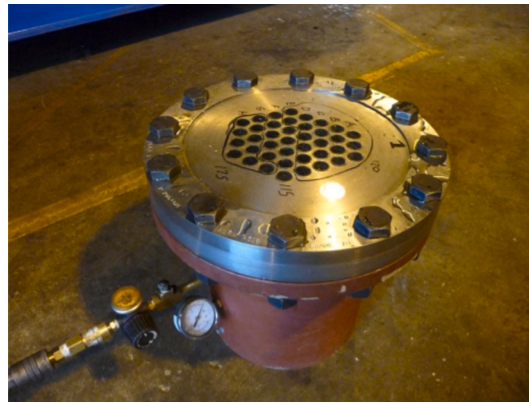
Fig. 24. Pneumatic testing of mock-up tube-to-tubesheet joint [320].
