# Integrating Image Processing and Machine Learning for the Non-Destructive Assessment of RC Beams Damage

**Citation:** Naderpour, H.; Abbasi, M.; Kontoni, D.-P.N.; Mirrashid, M.; Ezami, N.; Savvides, A.-A. Integrating Image Processing and Machine Learning for the Non-Destructive Assessment of RC Beams Damage. *Buildings* **2024**, *14*, 214. <https://doi.org/10.3390/buildings14010214>

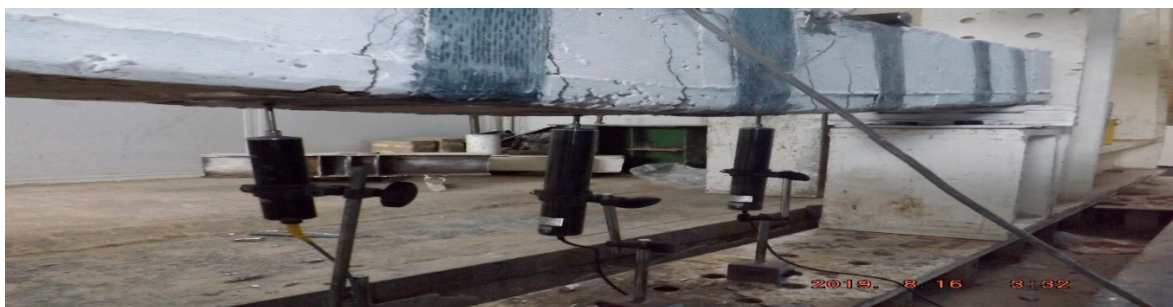
**Figure 1.** Recording of vertical changes in concrete beams.

High-quality cameras are employed to capture the crucial moments throughout the testing process, ensuring the reliability of the results from the subsequent image processing of the reinforced concrete beams. Specifically, only images of acceptable quality are selectively collected during the loading of the beam, as illustrated in Figures 1 and 2. A series of continuous image frames is documented at each stage of the experiment, offering a comprehensive view of the beam response to the applied loads. Figure 3 provides a glimpse into several loading frames for the SBDCM15-3 specimen, showcasing the meticulous documentation of the entire process, from the initiation of loading to the eventual failure of the specimen. This meticulous recording of images serves as the foundational step in the non-destructive testing process, allowing for the detailed analysis and validation of the beam structural behavior under varying conditions.

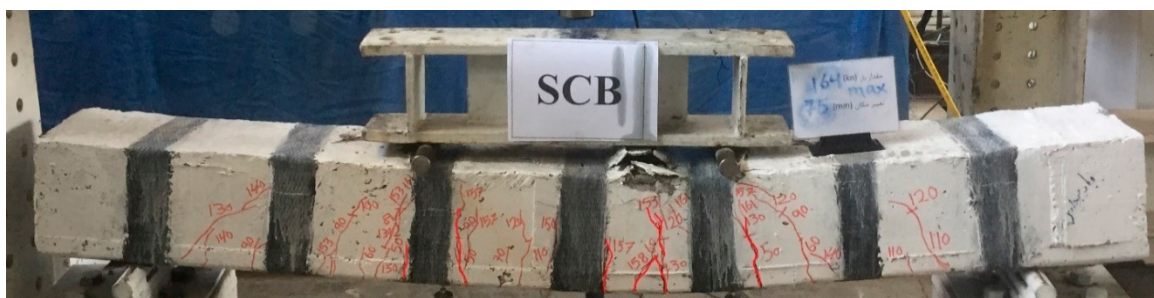
**Figure 2.** Depicting cracks to be subjected to image processing following beam failure.

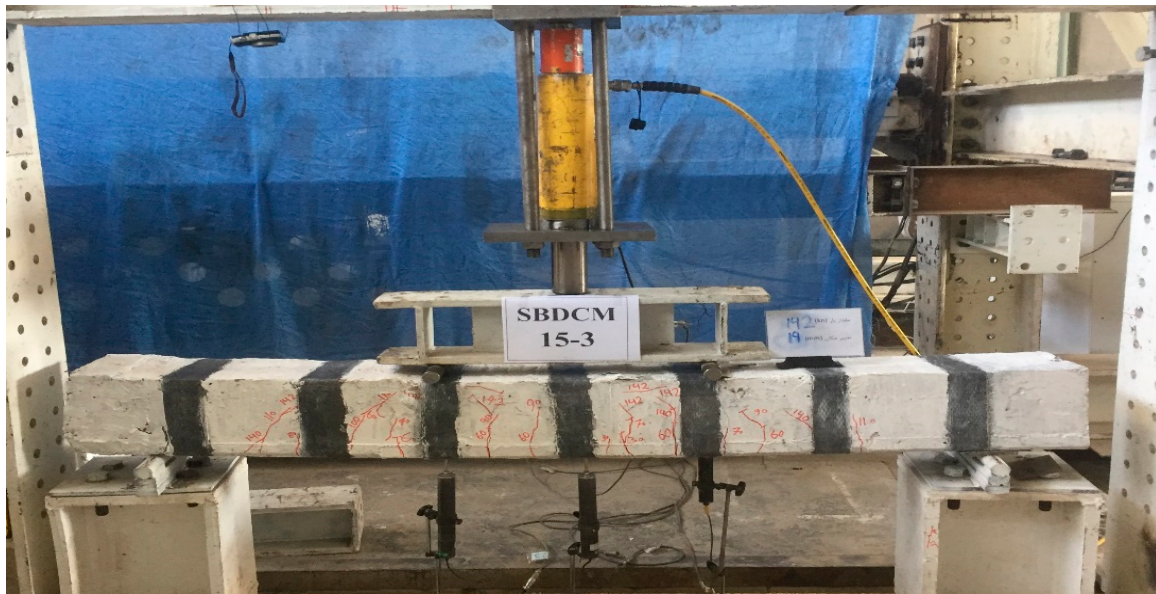
**Figure 3.** Image captured.

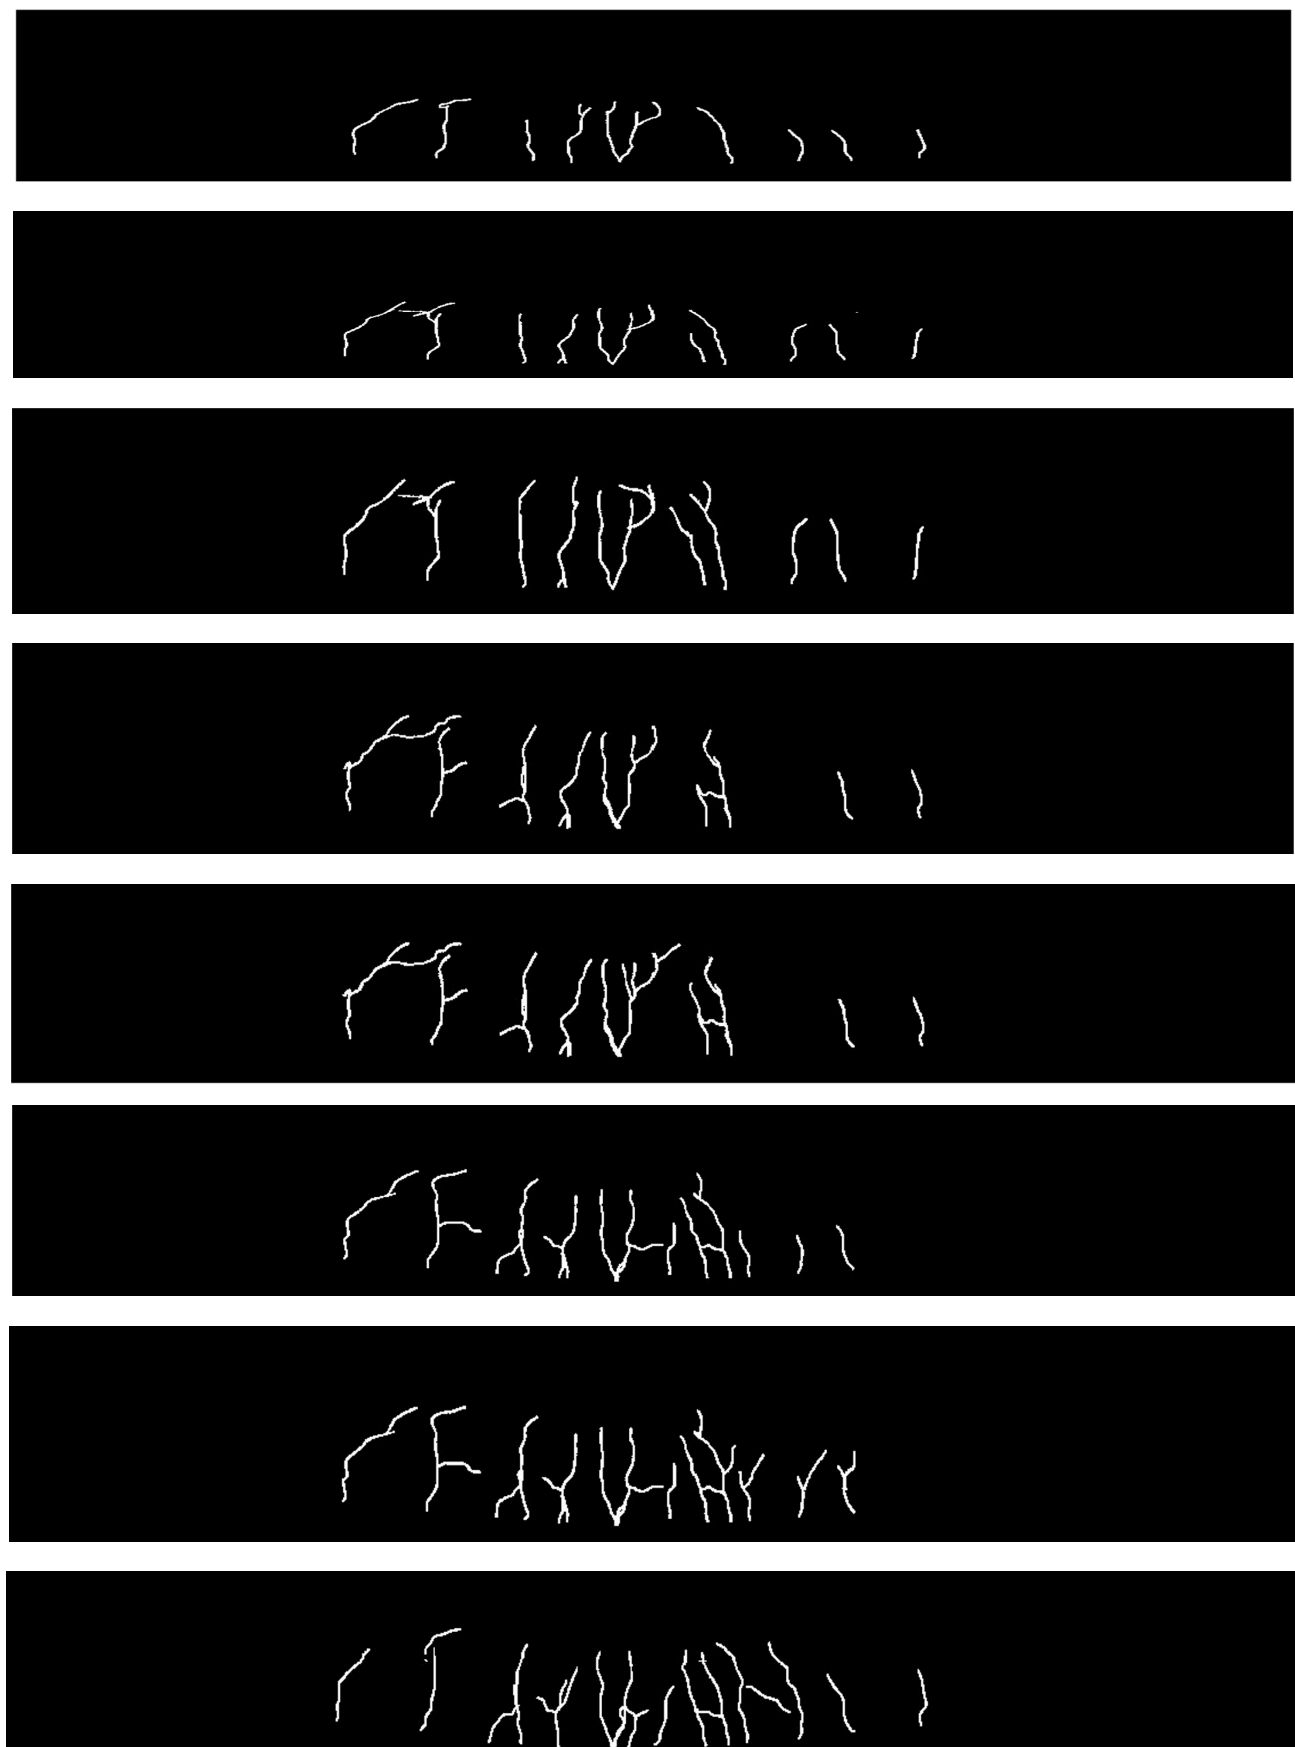
**Figure 5.** Processing of cracks in images with consideration of their growth and the loading conditions applied.

beam and input into the image processing tool in MATLAB software version 2019a. Figure 5 illustrates the processing of the image cracks while taking into account their growth. These models use the detected cracks to classify the beams into their respective categories. Subsequently, one image is selected from each folder, and the program automatically processes all the images within the folder. It is important to note that the time it takes for the program to read certain folders varies based on the image size and the number of cracks present. As the program sequentially processes all the images, it classifies them based on the detected cracks from the beginning to the end of the loading process.

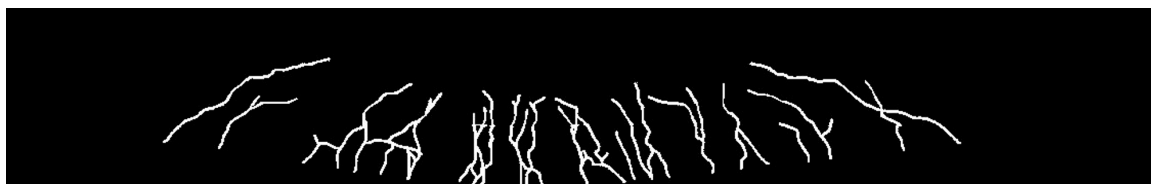
**Figure 7.** Image processing of cracks in CB beams.

comprehensive understanding of the crack patterns, contributing valuable insights into the structural integrity of the CB beams under examination. Figure 8 extends this exploration by illustrating the application of image processing to the detection and analysis of cracks in the CB beams. This visual representation serves as a testament to the effectiveness of the employed image processing techniques, showcasing their capability to discern and analyze the intricate details associated with crack formation and propagation. The meticulous examination of compliance modes, coupled with the nuanced analysis of image processing methods, has provided a rich reservoir of insights into the behavior of CB beams under various conditions. The combination of experimental observations, numerical modeling, and image processing techniques has facilitated a holistic understanding of the structural performance and failure mechanisms of the Cantilever-Bracket beams.

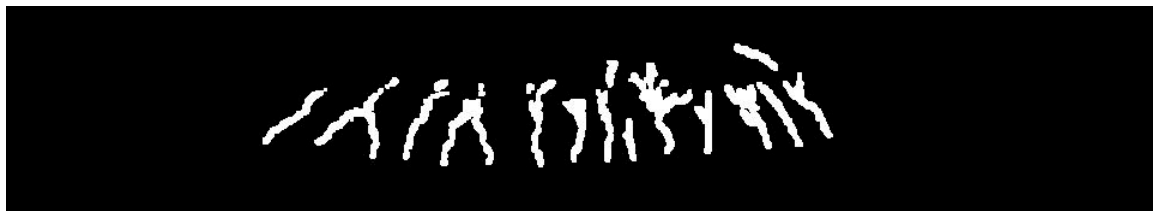
**Figure 9.** Image processing for cracks in BDCM (10-3) beams.

Figure 9 serves as a visual representation of the image processing techniques applied to cracks in the BDCM (10-3) beams, offering detailed insights into the intricate patterns of crack formation and propagation. This visual depiction enhances the comprehensibility

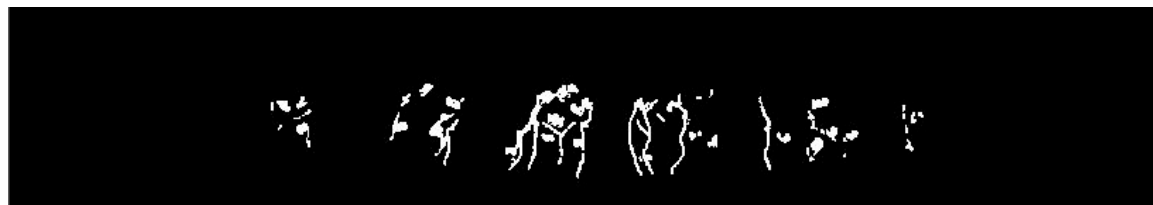
**Figure 10.** Image processing for cracks in SBDCM (10-3) beams.

of the image processing methodology employed, facilitating a deeper understanding of the structural response to various loading conditions. Furthermore, Figure 10 extends this exploration by illustrating the image processing techniques specifically tailored for cracks in the SBDCM (10-3) beams. This visual representation provides a focused examination of the cracks in this particular specimen, contributing to a more granular understanding of the failure mechanisms within the SBDCM context. The analysis of the compliance modes and image processing methods has unraveled valuable insights into the structural behavior of the SBDCM beams. The elevated compliance observed in the SBDCM (10-0.5) (15-1) specimen, coupled with the nuanced comparisons between the image processing modes and methods, deepens our understanding of the intricate interplay between the failure patterns and structural responses for the studied scenarios.

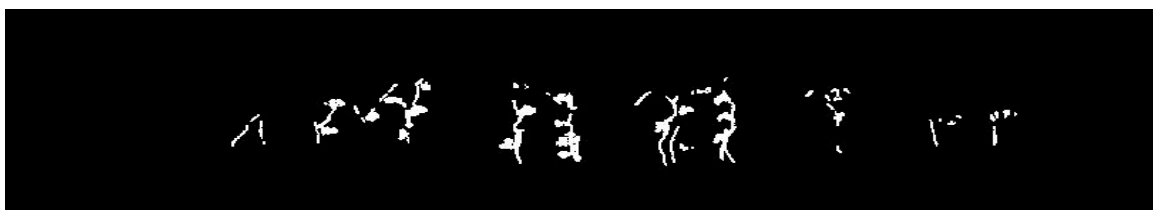
**Figure 11.** Image processing for cracks in SBDCM (15-1) beams.

A comprehensive overview of all the modes underscores a consistent alignment with the SBDCM specimens, with nearly identical results observed across the various image processing modes. This robustness of the outcomes emphasizes the reliability of the methodologies employed, providing a solid foundation for understanding the structural behavior and failure mechanisms. Intriguingly, in both the 7- and 15-specimen scenarios, the KNN method appears to emulate the BDRS similarity mode, a phenomenon possibly linked to the clustering of cracks in a specific region of the beam devoid of FRP. This observation introduces a layer of complexity into the interpretation of the results, highlighting the sensitivity of image processing methods to localized conditions and material characteristics. A pivotal revelation emerges in the comparative analysis of the two primary methods, with the SVM approach exhibiting a closer correspondence to the expected response than the KNN method. This observation underscores the efficacy of the SVM model for capturing and predicting structural behavior, offering valuable insights for future applications and refinements of analysis methodologies (see Figures 11 and 12).

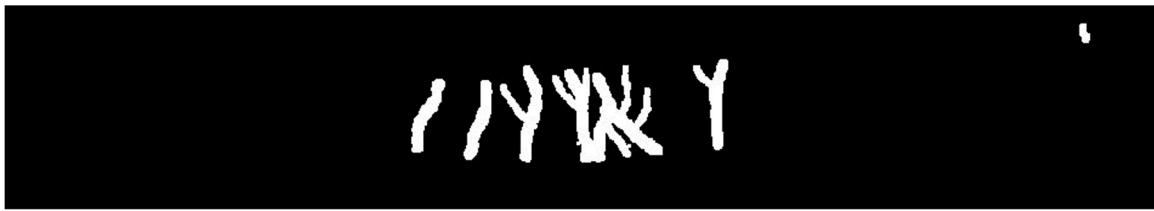
**Figure 12.** Image processing for cracks in BDCM (15-1) beams.

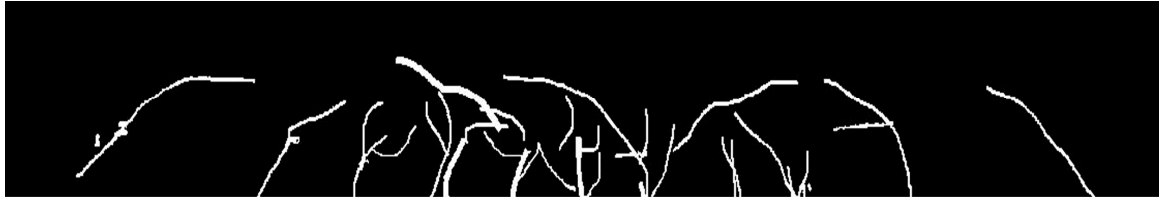
**Figure 17.** Image processing for cracks in BDCM (15-3) beams.

The images extracted from the image processing, as depicted in Figures 17 and 18, are subjected to evaluation across three different modes. In the cases under examination, the SBDCM (15-1) specimen stands out as the most compliant. An analysis of the processed images indicates that the specimen reinforced with FRP exhibits variations in crack length, characterized by both decreases and increases. In contrast, the FRP-free specimen, because

of a mid-span failure (in the center) measuring 15.3 cm, primarily exhibits the formation of cracks within the same area. In both instances, regardless of the presence of FRP reinforcement, cracking initiates at the center and subsequently experiences growth as a consequence of the applied force.

The images extracted through the image processing, illustrated in Figures 17 and 18, undergo comprehensive evaluation across three distinct modes. Notably, within the scope of the examined cases, the SBDCM (15-1) specimen emerges as particularly noteworthy for its exceptional compliance. A meticulous analysis of the processed images unveils the distinctive characteristics of the behavior of the specimen reinforced with FRP. This particular specimen exhibits variations in crack length, showcasing a dynamic interplay of both decreases and increases in crack dimensions. Conversely, its FRP-free counterpart, experiencing a mid-span failure at the center measuring 15.3 cm, predominantly displays the formation of cracks within the same spatial confines. Regardless of the presence or absence of FRP reinforcement, the initiation of cracking consistently takes place at the center and subsequently undergoes growth in response to the applied force. This observation not only highlights the unique response of the SBDCM (15-1) specimen, but also underscores the influence of FRP reinforcement on crack evolution. The dynamic nature of the crack length variations in the FRP-reinforced specimen adds a layer of complexity to the understanding of failure mechanisms, providing valuable insights into the material's behavior under loading conditions. The examination of the SBDCM (15-1) specimen through image processing reveals distinctive compliance characteristics and nuanced crack evolution patterns, contributing to a deeper understanding of the structural response in the presence of FRP reinforcement. These findings hold implications for the design and analysis of structures, particularly those incorporating FRP components, and add valuable dimensions to the ongoing exploration of material behavior and failure mechanisms.

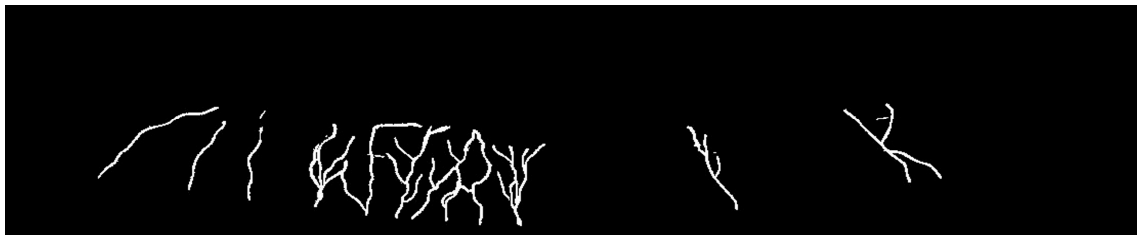
**Figure 20.** Image processing for cracks in BDCM (10-0.5) (15-1) beams.

The scrutiny of the images derived from the image processing, delineated in Figures 20 and 21, involves a meticulous assessment under three distinct modes. Within the ambit of this investigation, the SBDCM (15-1) and SBDCM (15-3) specimens emerge as standouts, exhibiting the highest compliance. A closer inspection of the processed images unveils the distinctive behaviors of the specimen reinforced with FRP. Notably, this specimen undergoes direct crack growth without branching, shedding light on the specific influence of FRP reinforcement on crack propagation. In stark contrast, its FRP-free counterpart, experiencing both mid-span and one-third span failures, has most of the cracks concentrated in the corresponding areas. Irrespective of FRP reinforcement, the initiation of cracking consistently occurs at the center and one-third span, followed by their growth due to the applied force. All the examined cases demonstrate compliance with SBDCM (15-1), SBDCM (15-3), and BDCM (15-3), with the other image processing modes yielding nearly identical results. This uniformity in the outcomes is particularly due to the presence of beam damage at the center, emphasizing the critical role of damage location in shaping structural responses.

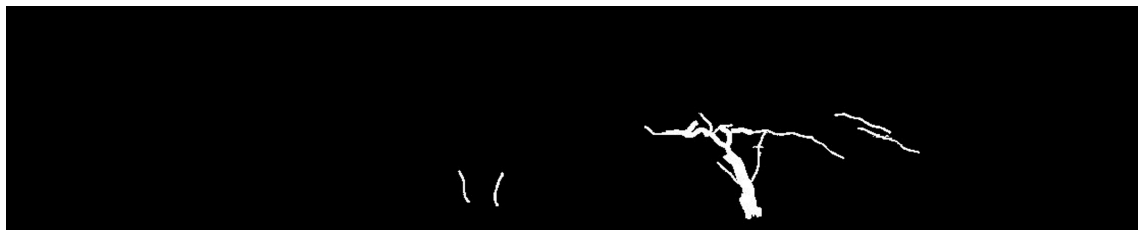
**Figure 23.** Image processing for cracks in BDRA beams.

The scrutinized images obtained from the image processing, as illustrated in Figures 23 and 24, undergo a thorough evaluation through three distinct modes. Notably, within the cases under examination, the specimen experiencing a one-third span failure emerges as the epitome of compliance. In the comprehensive scenario involving 15 specimens, the SVM processing stands out for its efficacy at effectively detecting the one-third span failure. This particular observation underscores the discriminative power of SVM for capturing nuanced structural responses, especially in scenarios with complex failure modes. A detailed analysis of the processed images unravels intricate details about the specimen reinforced with FRP. This specimen exhibits crack growth, a phenomenon attributed to

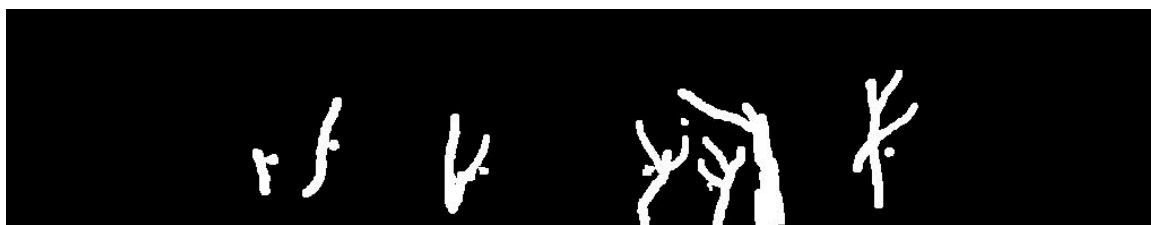
**Figure 24.** Image processing for cracks in SBDRA beams.

the presence of the FRP reinforcement. While cracks also manifest in other regions of the beam, they are less pronounced, predominantly due to a higher applied load. The degree of crack opening, intricately reflected in the line width of the formed cracks in the processed images, provides valuable insights into the varying degrees of structural damage and the impact of FRP reinforcement on crack propagation. Conversely, in the FRP-free counterpart, substantial cracks are concentrated in the same area, indicative of a one-third span failure. Regardless of the presence or absence of FRP reinforcement, the consistent initiation of cracking at the one-third span is a key observation, followed by its further growth in response to the imposed force. This consistent pattern underscores the reproducibility of failure mechanisms and the influence of specific failure modes on structural behavior. The meticulous assessment of images through diverse processing modes reveals a rich tapestry of compliance nuances. The effectiveness of SVM processing for detecting the one-third span failure in the 15-specimen scenario adds a layer of sophistication to the analysis. The differential crack patterns observed in the FRP-reinforced and FRP-free specimens contribute to a deeper understanding of the interplay between the material composition, applied load, and crack propagation. These insights hold significance for refining structural design considerations and advancing the understanding of failure mechanisms in complex scenarios.

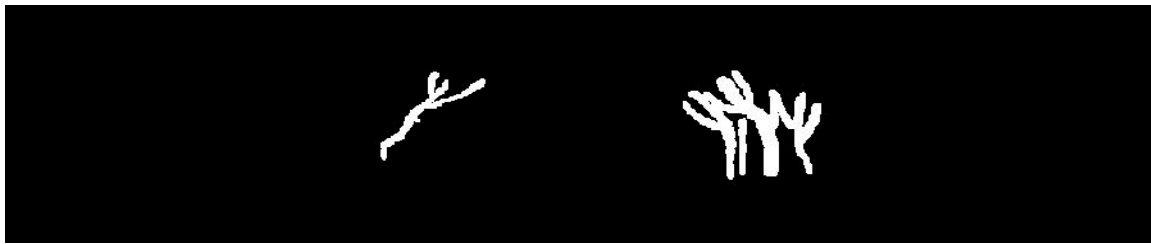
**Figure 27.** Image processing for cracks in BDRS beams.

Figures 26 and 27 present a visual exploration of the images derived from the image processing, inviting scrutiny across three distinct modes. A notable highlight within the considered cases is the specimen showcasing a one-third span failure, exhibiting the pinnacle of compliance. Remarkably, the eight-specimen scenario stands out for achieving the highest level of compliance, underscoring the significance of this localized failure mode. Within the 15-specimen scenario, the effectiveness of SVM processing for detecting the one-third span failure becomes evident. This nuanced capability of SVM adds a layer of sophistication to the analysis, particularly in scenarios with complex failure modes. A detailed analysis of the processed images offers valuable insights into the behavior of the specimen reinforced with FRP. This specimen undergoes crack growth, with the extent of crack formation in other sections of the beam being notably less pronounced. The diminished prominence of cracks in these areas can be attributed to the higher applied load. The degree of crack opening, represented by the line width in the processed images, serves as a quantitative measure of the structural response, enriching the understanding of the impact of FRP reinforcement on crack propagation. Conversely, in its FRP-free counterpart experiencing a one-third span failure, significant cracks are concentrated in the same area. The consistent observation of crack initiation at the one-third span, followed by further growth due to the imposed force, highlights the reproducibility of failure mechanisms and their sensitivity to the presence or absence of FRP reinforcement. Across all the cases, compliance with BDCM (15-1) is consistently demonstrated, with the other image processing modes yielding nearly identical results. The heightened response accuracy observed for the eight-specimen scenario, primarily attributed to the presence of a one-third span failure, adds a critical dimension to the analysis. In this context, the SVM method outperforms the KNN method, emphasizing its adaptability for capturing nuanced structural responses.
