# TIME EFFECT OF ALKALI-AGGREGATE REACTION ON PERFORMANCE OF CONCRETE

By Osama A. Mohamed,<sup>1</sup> Kevin L. Rens,<sup>2</sup> P.E., Associate Members, ASCE,  
and Judith J. Stalnaker,<sup>3</sup> P.E., Member, ASCE

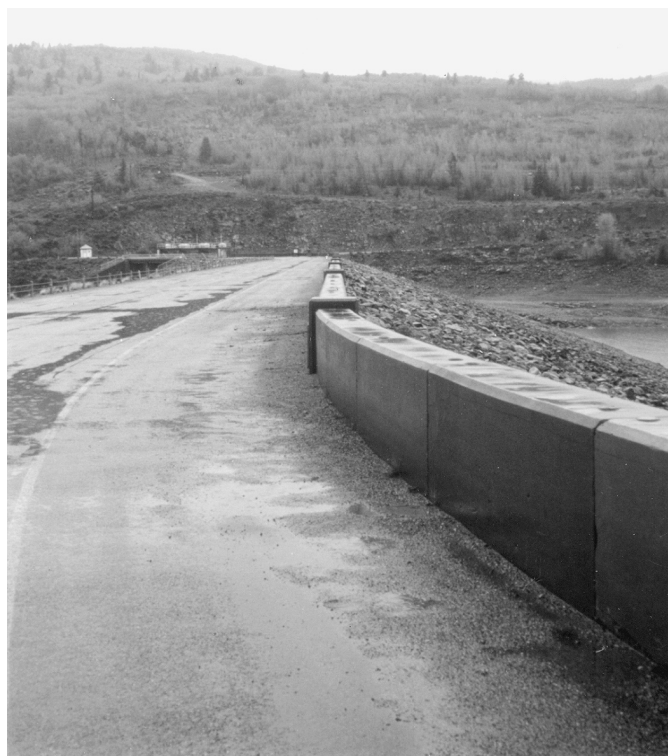
FIG. 1. Overall View of Wall Panels (Facing South)

The parapet wall, which was constructed in the 1940s, consists of 104 panels. Fig. 1 shows a general view of the parapet wall. Each panel is approximately 2.74 m long  $\times$  1.22 m tall  $\times$  0.41 m thick (1 m = 3.28 ft). Data presented in this paper were obtained from testing of the cement, aggregate, and concrete used in the construction of the parapet wall at the Green

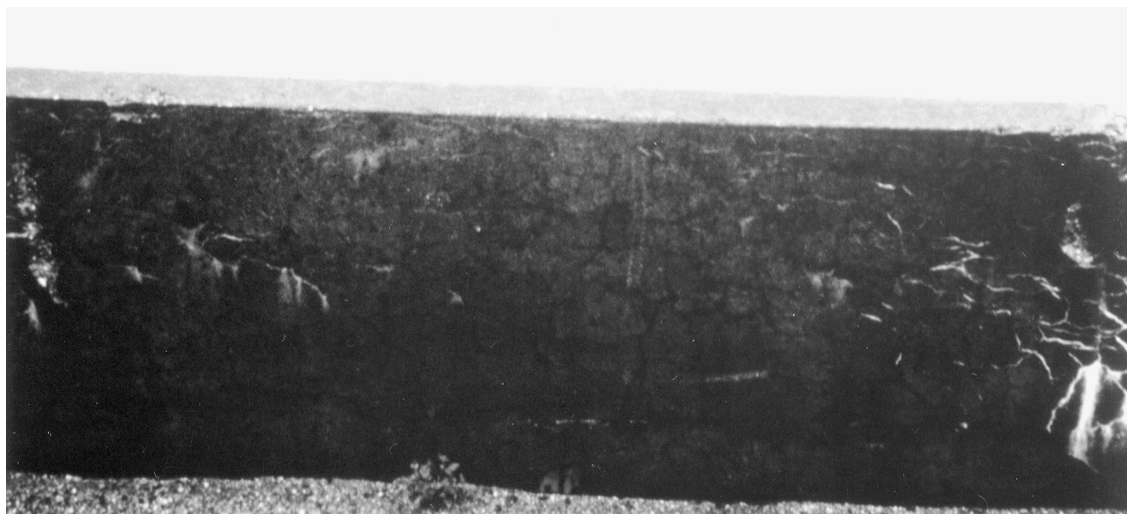
**FIG. 3. Panel No. 24-4 (Notice Efflorescence, Pattern Cracking and Change of Color)**

This panel was constructed using cement Type 24, which can be classified as ASTM Type II cement. Cement Type 24 contained a medium-high equivalent alkalis amount of 0.94%. No significant signs of distress were observed within the first 3 years of the wall. In 1997, this panel became one of the worst in overall condition. Significant amounts of silica gel were produced by the reaction and caused serious cracking that exceeded 15 mm. Pattern cracking, discoloration, and efflorescence represent the most apparent signs of distress, as shown in Fig. 3. Although the amount of equivalent alkalis in this cement type was slightly less than that present in Type 14-1, Panel 24-4 was much more distressed than Panel 14-1.

| Panel no.<br>(1) | 1943 inspection<br>(2) | 1946 inspection<br>(3) | 1997 inspection<br>(4) |
|---|---|---|---|
| 24-4 | Nothing to report except very small deposit of carbonate just below corner crack | Horizontal crack at conduit over north two-thirds of panel; maximum opening 0.051 mm mm; carbonate deposit has disappeared | Extensive wide pattern cracking covers entire area, maximum crack width has exceeded 15.2 mm; panel is fully covered with orange discoloration, and many cracks are covered with efflorescence |

Panel 24-4 gained strength continuously over the first 2 years. Because of alkali-aggregate reaction, this panel lost >36% of its compressive strength between 2 and 53 years. This is to be compared to Type 14 cement that contained approximately the same
